## ALL (ATA 57) MICROBIOLOGICALLY INDUCED CORROSION IN WING FUEL TANKS

By Jose Veciana, Service Engineering Manager

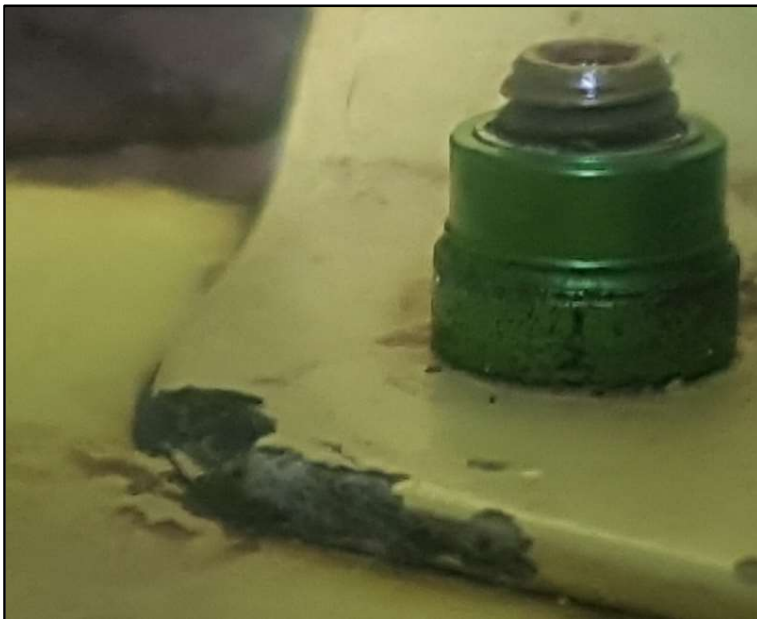
During the performance of internal wing tank inspections at the Gulfstream Savannah Service Center, several aircraft revealed the presence of corrosion due to Microbiologically Influenced Corrosion (MIC). If left unchecked, corrosion of this nature can progress quickly, requiring major repairs to the wing structure (See Figure 1, on page 4).

Figure 1  
Corner of wing rib flange with missing material due to MIC

Note:  
Pitting on the green Hi-Lok collar also due to the effects of MIC

Consistent water draining of the aircraft fuel tanks is key to maintaining a healthy fuel system. Gulfstream is revising all Airplane Flight Manuals to include this process as part of the aircraft preflight. Water draining (sumping) procedures are located in the Aircraft Maintenance Manual (AMM) ATA 28, under Fuel Tank Sumping. Gulfstream has proactively designed a new tool that will soon be available for most aircraft models that will allow worry-free sumping of water from the aircraft fuel system, mitigating issues encountered with the new sump valve design.

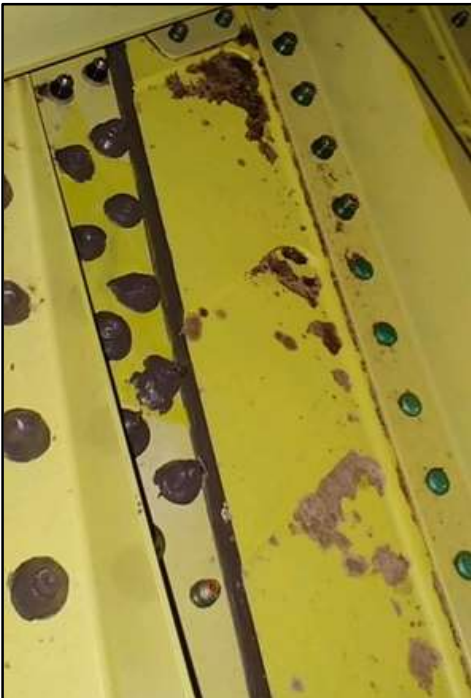
MIC is usually seen in discrete areas on the fuel tank, typically in low-lying areas of the wing, but are not always limited to these areas where water will settle. Two photographs of typical microbiological growth are shown in Figures 2 and 3 (on page 4).

Figure 2  
Areas of typical microbiological growth on the lower surface of a wing tank

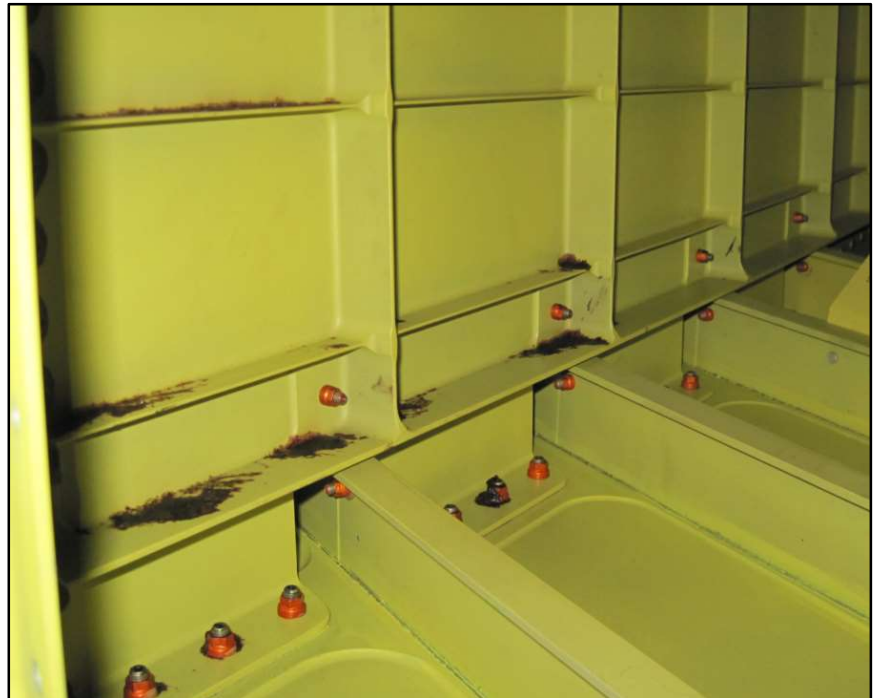
Figure 3  
Areas of typical microbiological growth on a wing spar
